SUBJECT: BUDD INLET SURVEY OF AUGUST 27, 1975

DATE: August 28, 1975

State of  
Washington  
Department  
of Ecology

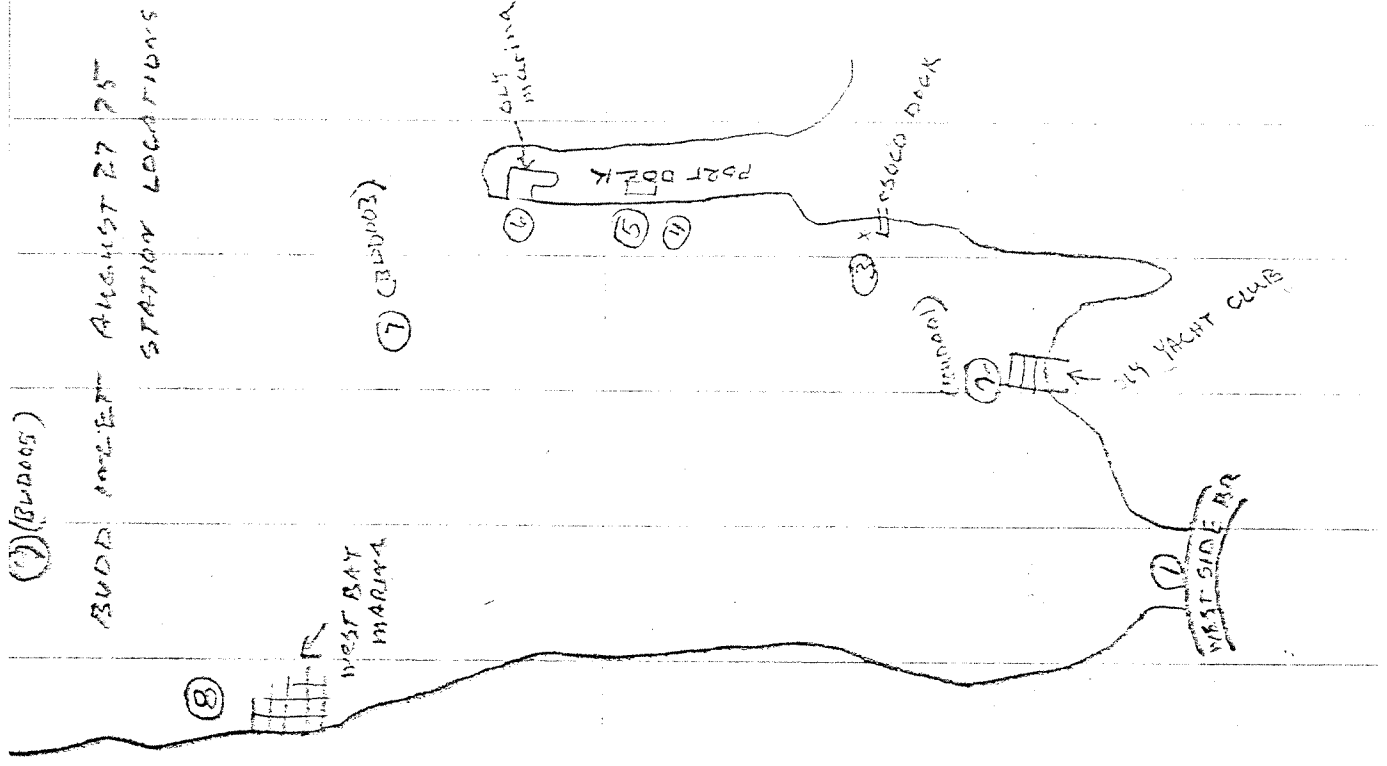
BUDD INLET / AUGUST 27-75

DISSOLVED OXYGEN OBSERVATIONS

STATION	IBC	WINKLER
1	5.2	5.6
2	2.9	3.1
3	8.0*	6.4
4	1.2*	
5	.3*	.4
6	.3*	1.5
7	4.2	
8	10.2**	8.7
9	>15	13.4

\* ERRATIC READINGS DUE TO SHIFTING "POCKETS" OF LOW DO.

\*\* ALGAE BLOOM ELEVATING D.O.

✓ UNCORRECTED DO'S - SALINITY SAMPLES NOT TAKEN. IBC DO'S WOULD BE LOWERED SOMEWHAT

IN DIRECT RELATIONSHIP TO NACL CONTENT. GREATEST CHANGE WOULD OCCUR AT STATIONS 3, 7, 9 AND THE LEAST AT 1 & 2 (FRESH H2O FROM CAPITOL LAKE)
